**Flood Control Project Maintenance  
Levee Inspections**

**Fall 2018 Levee Maintenance Deficiency Summary Report**

**Sacramento River Basin**

**Reclamation District No. 1500 Sutter Basin**

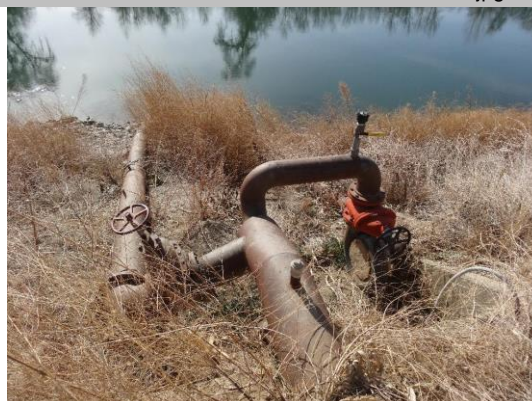
Photo 1 of 3 : UCIP\_FA\_2018\_28925\_53210.jpg

Comment Code						
Inspector Comment						
FS_ID:28925 DS_ID:20059 EP_NO: N/A Repair Type: Non-Urgent Crossing Status: Found UCIP Comments: Pump removed.Obstructed siphon breaker in CMP riser on landside. FIELD_STRUCT_DESC: 12-inch steel irrigation discharge pipe through the levee, 4.3 feet below the crown. One cutoff wall. 1.5-inch conduit through the levee, 2 feet below the crown. Slant type centrifugal pumping plant on the riverbank removed during the winter months and a steel plate is bolted to the end of the pipe. Gate valve on the waterside (WS). Siphon breaker in a 24-inch corrugated metal pipe (CMP) riser on the landside (LS) shoulder. 8-foot by 6-foot, inside measurements, concrete distribution box and meter pole with switch panel at the LS toe. (12-inch steel irrigation discharge pipe through the levee and slant type centrifugal pumping plant retained under Permit No. 8506, 1972 - Eugene C. Reel et al.). [Additional Reference(s): DWR Levee Log, 2005. USACE Sacramento O&M Manual 128, March 1960, (HLM 10.81)]. FS Date: 1/10/2014

WS view: pipe, pump (removed and plugged with plywood), headwall, and appurtenances on river bank.

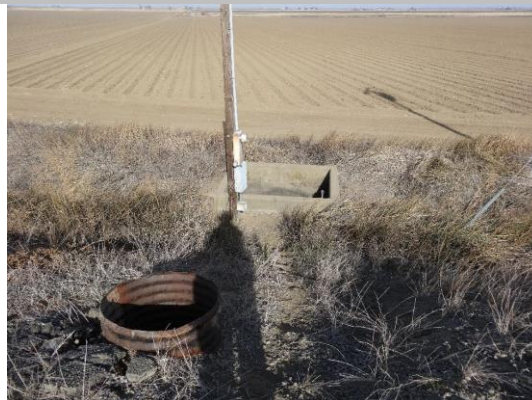
Photo 2 of 3 : UCIP\_FA\_2018\_28925\_53209.jpg

LS view: siphon breaker in CMP riser (bottom) on levee slope and concrete distribution box (top) on levee toe.

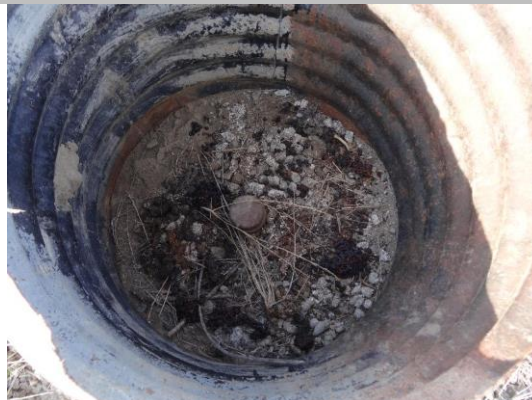
Photo 3 of 3 : UCIP\_FA\_2018\_28925\_53208.jpg

LS view: obstructed siphon breaker in CMP riser (bottom) on levee slope.

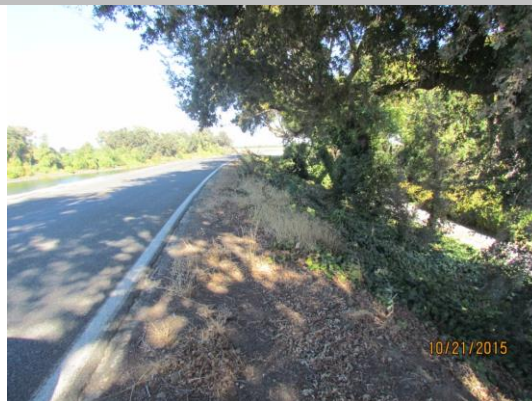
Photo 1 of 1 : FA\_2018\_RD1500\_189\_20\_20180904\_00009.jpg

LM Start	11.30	Rating **	M	Issue No.	20
LM End	11.30	Issue Type +	En	Location *	LS
Category	Earthen Levee			GPS Latitude/Longitude	
				Start	End
Item	Vegetation			38.866383 °	38.866383 °
				-121.745911 °	-121.745911 °
DWR ID	DWR_RD1500_01_s_2012_20				
Comment Code					
V6 : Landscaping					
Inspector Comment					
Permitted landscape needs maintenances (PN: 10041)

View of the landscaping on the landward side of the levee looking upstream. Fall 2015.

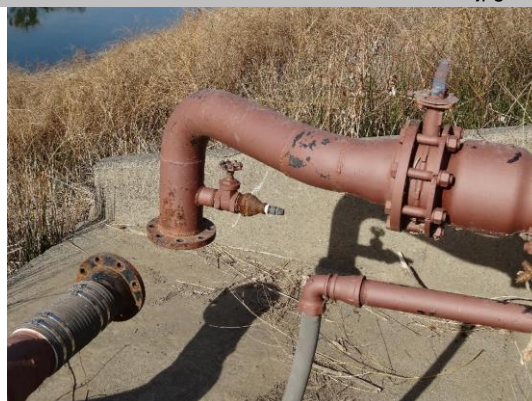
Photo 1 of 3 : UCIP\_FA\_2018\_50198\_52220.jpg

Comment Code						
Inspector Comment						
FS_ID:50198 DS_ID:20061 EP_NO: 10041 Repair Type: Non-Urgent Crossing Status: Found UCIP Comments: 08/29/2016 Depressions cited previously are a make-shift staircase and not an indication of a problem with pipe. Pipe partiallay exposed on LS slope which should be backfilled. Crossing has been downgraded from Urgent to Non-Urgent. (K. Fazel - UCIP)01/10/2014 Depressions on both sides of the levee slope. It needs more investigation.Pump removed. (P. Amatya - DWR) FIELD_STRUCT_DESC: 8-inch steel irrigation discharge pipe through the levee, 4 feet below the crown. One corrugated metal cutoff wall. Pump and gate valve on a concrete pump platform on the riverbank. Corrugated metal switch house on the waterside (WS) slope. Meter pole on the WS shoulder. 8-foot by 6-foot, inside dimensions, concrete distribution box on the landside (LS). Overhead power line crosses the levee. Pole at the LS toe. Installed by USACE in 1952. (8-inch steel irrigation discharge pipe through the levee, pump, and all other appurtenances retained under Automatic Board Order (ABO) issued as Permit No. 10041, 1974 - William J. Duffy Jr.) [Additional Reference(s): DWR Levee Log, 2005. USACE Sacramento O&M Manual 128, March 1960, (HLM 11.57)]. FS Date: 8/29/2016

WS view: pipe, pump (removed), headwall, and appurtenances on river bank.

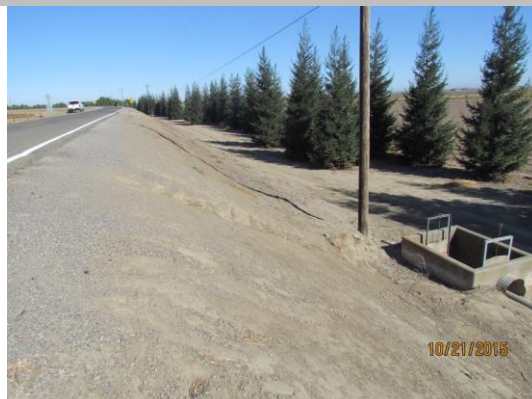
Photo 1 of 3 : FA\_2018\_RD1500\_189\_114\_20180904\_00049.jpg

LM Start	11.45	Rating **	M	Issue No.	114
LM End	11.45	Issue Type +	En	Location *	LS
Category	Earthen Levee			GPS Latitude/Longitude	
				Start	End
Item	Encroachments			38.868577 °	38.868577 °
				-121.746487 °	-121.746487 °
DWR ID	DWR_RD1500_01_f_2015_114				
Comment Code					
ST : Stairway					
Inspector Comment					
Landowner has dug stairs on the landside slope to irrigation equipment.

Perspective view of the concrete box on the landward side of the levee looking upstream. Fall 2015.

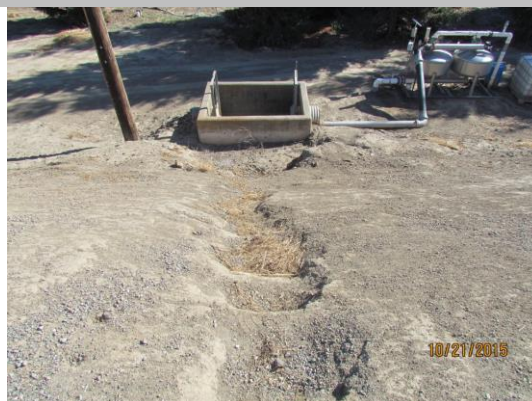
Photo 2 of 3 : FA\_2018\_RD1500\_189\_114\_20180904\_00050.jpg

There is erosion at the levee toe around the concrete box. There are also stairs leading down the slope. Fall 2015.

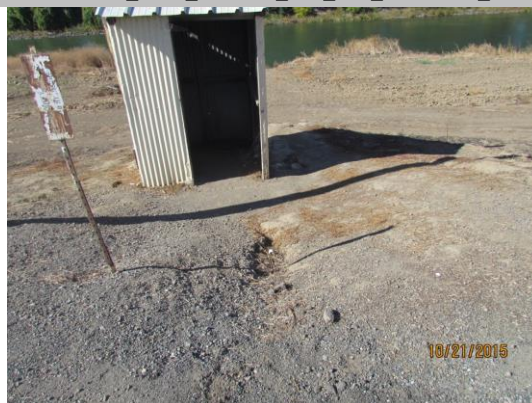
Photo 3 of 3 : FA\_2018\_RD1500\_189\_114\_20180904\_00051.jpg

There is slight erosion on the waterward side of the levee where the pipe seems to run through the levee. Fall 2015.

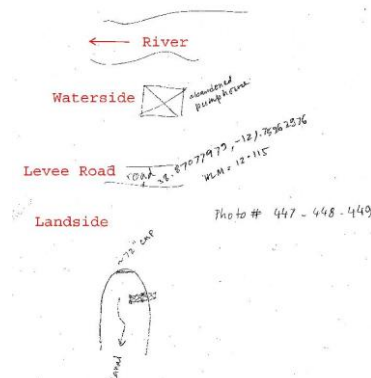
Photo 1 of 3 : UCIP\_FA\_2018\_41744\_51343.jpg

Sketch of Utility Crossing @HLM 12.115

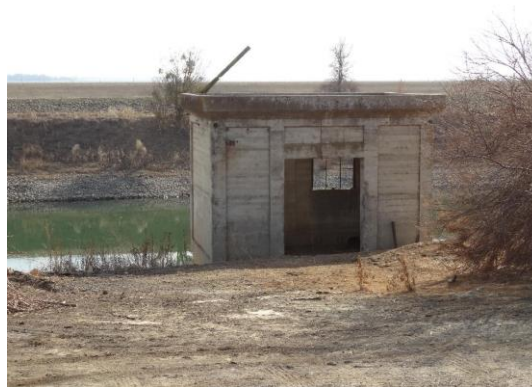
Photo 2 of 3 : UCIP\_FA\_2018\_41744\_51345.jpg

FS\_ID:41744  
DS\_ID:20008  
EP\_NO: N/A  
Repair Type: Non-Urgent  
Crossing Status: Indicator Found  
UCIP Comments: An abandoned pump house on waterside and a 72-inch corrugated metal pipe on landside. The pipe discharges into irrigation ditch (canal). Water was flowing during the field visit. Needs to verify from LMA whether this pipe is through the levee or not.  
FIELD\_STRUCT\_DESC: [State Ranch Bend Pumping Plant] 1 of 2: 36-inch by 42-inch reinforced concrete irrigation discharge culvert under the levee, 17 feet below the crown. Two concrete cutoff walls. Vertical pump on the riverbank. Slide gate on the waterside (WS) end. Wooden slide gate at the landside (LS) toe. Installed by USACE in 1947. (36-inch by 42-inch reinforced concrete irrigation discharge culvert under the levee, vertical pump, and all other appurtenances retained under Automatic Board Order (ABO) issued as Permit No. 10073, 1974 - Sutter Mutual Water Company, [Station 356+02]. To comply with Condition No. TWENTY of Board Order No. 9809 with plans to remove the old Pumping Plant No. 1 authorized under Permit No. 9809-A, 1976 - Sutter Mutual Water Company). [Additional Reference(s): DWR Levee Log, 1990. USACE Sacramento O&M Manual 128, March 1960, (HLM 12.12), two 48-inch by 42-inch concrete culverts referenced].

WS view: abandoned concrete pump house. No pump and pipe found.

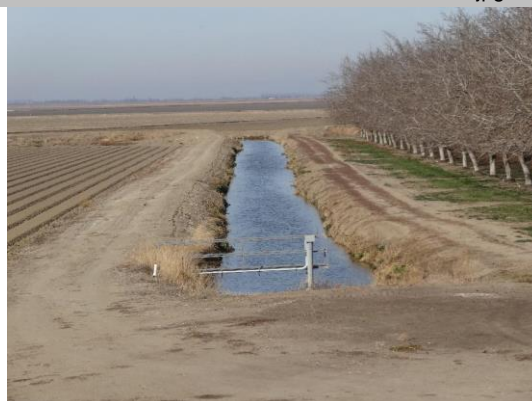
Photo 3 of 3 : UCIP\_FA\_2018\_41744\_51344.jpg

LS view: overview of irrigation ditch on toe of levee.

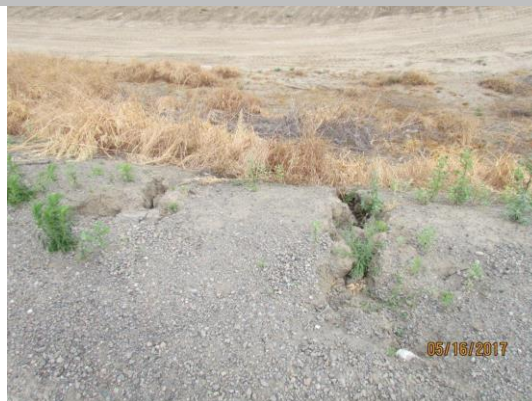
Photo 1 of 1 : FA\_2018\_RD1500\_189\_116\_20180904\_00052.jpg

LM Start	12.01	Rating **	M	Issue No.	116
LM End	12.01	Issue Type +	Ma	Location *	LS
Category	Earthen Levee			GPS Latitude/Longitude	
				Start	End
Item	Erosion / Bank Caving			38.870730 °	38.870730 °
				-121.752908 °	-121.752908 °
DWR ID	DWR_RD1500_01_s_2017_116				
Comment Code					
E2 : Schedule repair of erosion site prior to the next inspection.					
Inspector Comment					
Runoff erosion on landside levee slope.

View of erosion on landside slope. Spring 2017.

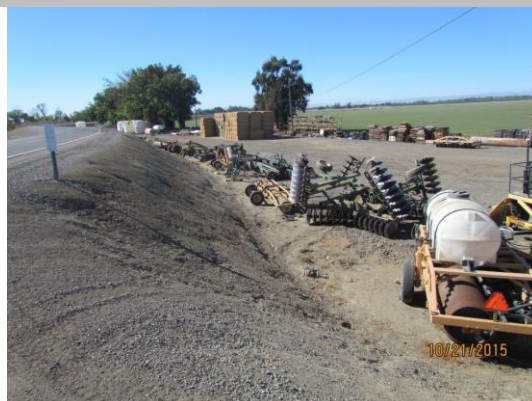
Photo 1 of 1 : FA\_2018\_RD1500\_189\_24\_20180904\_00010.jpg

LM Start	12.42	Rating **	M	Issue No.	24
LM End	12.53	Issue Type +	En	Location *	LS
Category	Earthen Levee			GPS Latitude/Longitude	
				Start	End
Item	Encroachments			38.868834 °	38.867492 °
				-121.760014 °	-121.760903 °
DWR ID	DWR_RD1500_01_s_2012_24				
Comment Code					
EQ : Equipment					
Inspector Comment

View of the equipment on the landward side of the levee looking upstream. Fall 2015.

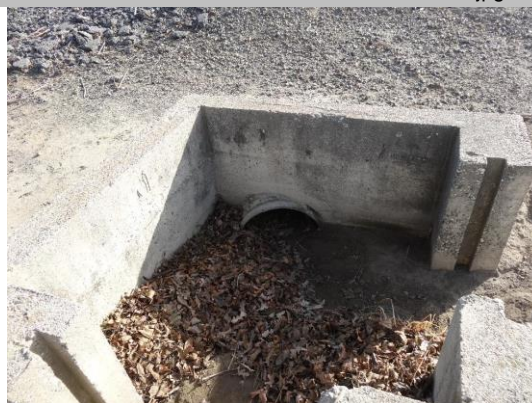
Photo 2 of 3 : UCIP\_FA\_2018\_50197\_52424.jpg

Comment Code						
Inspector Comment						
FS_ID:50197 DS_ID:20063 EP_NO: 10061 Repair Type: Non-Urgent Crossing Status: Found UCIP Comments: 08/29/2016 Same as last inspection. (K. Fazel - UCIP)01/10/2014 Needs proper abandonement. (P. Amatya - DWR) FIELD_STRUCT_DESC: *ABANDONED* 18-inch corrugated metal gravity drainage pipe through the levee, 15 feet below the crown. Slide gate in a 4-foot by 4-foot concrete box at the waterside (WS) toe. Concrete box at the landside (LS) toe. Pipe crosses overflow area to the river. Installed by USACE in 1944. (18-inch corrugated metal gravity drainage pipe through the levee and all other appurtenances retained under Automatic Board Order (ABO) issued as Permit No. 10061, 1974 - Roger L. Matteoli). [Additional Reference(s): DWR Levee Log, 2005. USACE Sacramento O&M Manual 128, March 1960, (HLM 12.69)]. FS Date: 8/29/2016

LS view: concrete intake box on levee toe.

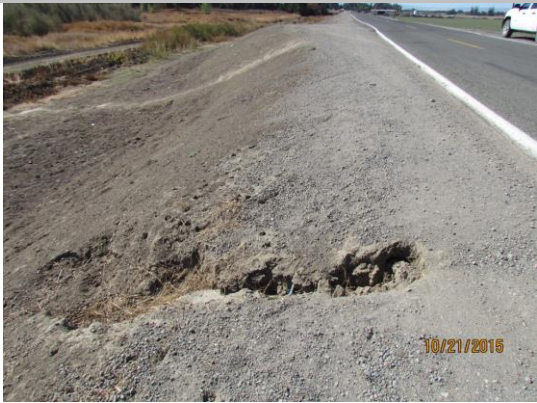
Photo 2 of 2 : FA\_2018\_RD1500\_189\_118\_20180904\_00054.jpg

View of the erosion on the waterward side of the levee looking upstream.  
Fall 2015.

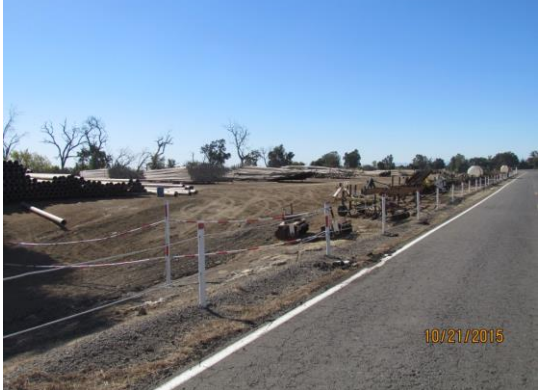
Photo 1 of 1 : FA\_2018\_RD1500\_189\_25\_20180904\_00011.jpg

View of the equipment on the waterside shoulder of the levee looking upstream. Fall 2015.

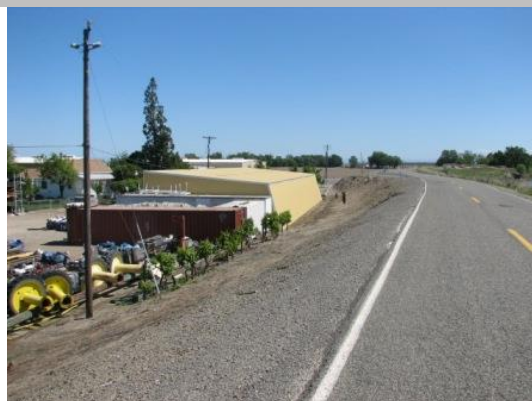
Photo 1 of 1 : FA\_2018\_RD1500\_189\_26\_20180904\_00012.jpg

LM Start	13.01	Rating **	M	Issue No.	26
LM End	13.01	Issue Type +	En	Location *	LS
Category	Earthen Levee			GPS Latitude/Longitude	
				Start	End
Item	Encroachments			38.863438 °	38.863438 °
				-121.768212 °	-121.768212 °
DWR ID	DWR_RD1500_01_s_2012_26				
Comment Code					
BU : Building					
Inspector Comment

The building's backside was built into the toe of the levee.

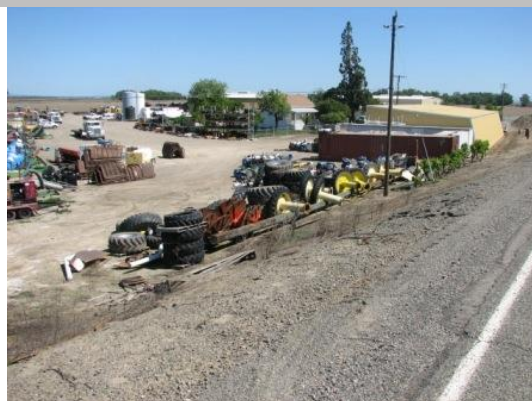
Photo 1 of 1 : FA\_2018\_RD1500\_189\_992\_20180904\_00083.jpg

LM Start	13.05	Rating **	M	Issue No.	992
LM End	13.05	Issue Type +	En	Location *	LS
Category	Earthen Levee			GPS Latitude/Longitude	
				Start	End
Item	Encroachments			38.863081 °	38.863081 °
				-121.768781 °	-121.768781 °
DWR ID	DWR_RD1500_01_s_2012_992				
Comment Code					
EQ : Equipment					
Inspector Comment					
There are equipment and tires at this location.

Next to the building there are tires and axles stored at the toe.

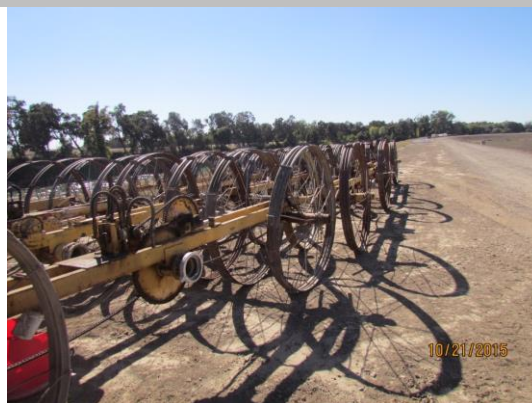
Photo 1 of 1 : FA\_2018\_RD1500\_189\_119\_20180904\_00055.jpg

LM Start	13.78	Rating **	M	Issue No.	119
LM End	13.82	Issue Type +	En	Location *	WS
Category	Earthen Levee			GPS Latitude/Longitude	
				Start	End
Item	Encroachments			38.859679 °	38.859201 °
				-121.780862 °	-121.781276 °
DWR ID	DWR_RD1500_01_f_2015_119				
Comment Code					
EQ : Equipment					
Inspector Comment

View of the equipment on the crown of the levee looking upstream. Fall 2015.

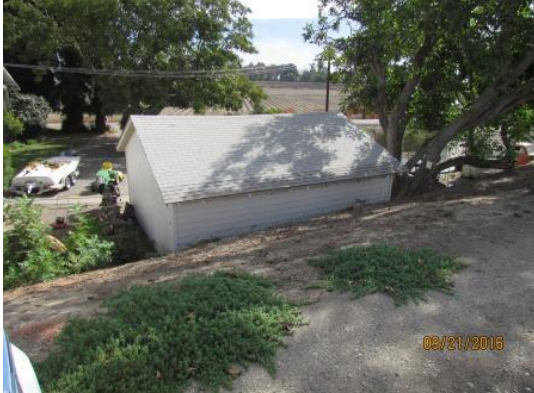
Photo 1 of 1 : FA\_2018\_RD1500\_189\_138\_20180904\_00069.jpg

View of a building encroaching levee on landside toe. Fall 2016.

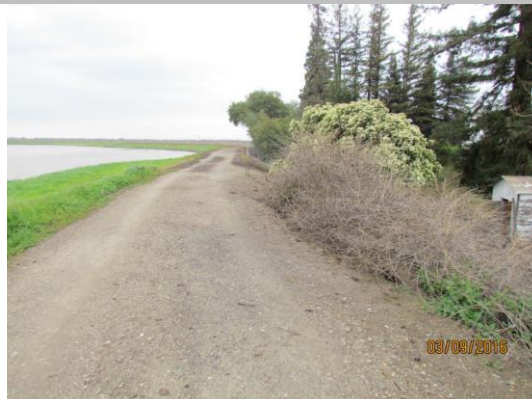
Photo 1 of 1 : FA\_2018\_RD1500\_189\_31\_20180904\_00015.jpg

LM Start	14.24	Rating **	M	Issue No.	31
LM End	14.28	Issue Type +	En	Location *	LS
Category	Earthen Levee			GPS Latitude/Longitude	
				Start	End
Item	Vegetation			38.861335 °	38.861913 °
				-121.783605 °	-121.783751 °
DWR ID	DWR_RD1500_01_s_2012_31				
Comment Code					
V6 : Landscaping					
Inspector Comment

View of the landscaping on the landward side of the levee looking upstream. Spring 2016.

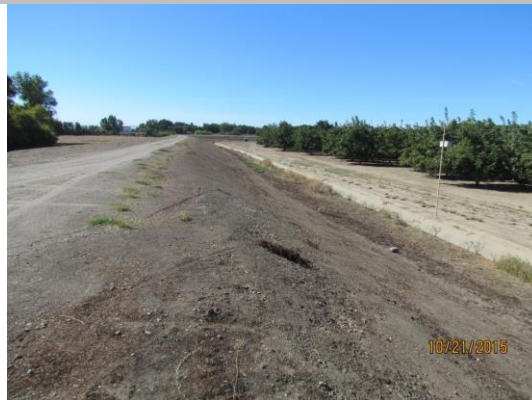
Photo 1 of 1 : FA\_2018\_RD1500\_189\_969\_20180904\_00080.jpg

LM Start	14.71	Rating **	M	Issue No.	969
LM End	15.76	Issue Type +	En	Location *	LS
Category	Earthen Levee			GPS Latitude/Longitude	
				Start	End
Item	Encroachments			38.865395 °	38.871827 °
				-121.789402 °	-121.804158 °
DWR ID	DWR_RD1500_01_s_2012_969				
Comment Code					
DT : Ditch					
Inspector Comment					
Ditch is at the levee toe.

View of the ditch on the landward side of the levee looking upstream.  
Fall 2015.

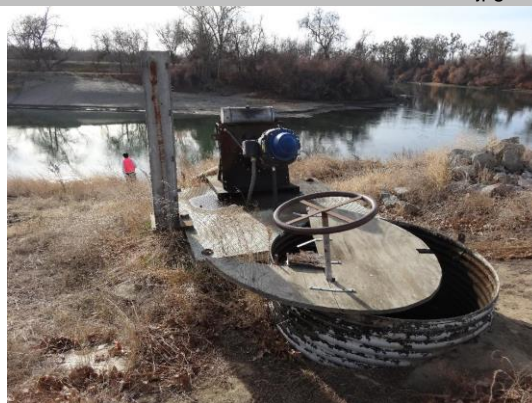
Photo 1 of 3 : UCIP\_FA\_2018\_28486\_52461.jpg

LM Start	15.11	Rating **	M	Issue No.	2573	
LM End	15.11	Issue Type +	En	Location *		
Category	Supplemental			GPS Latitude/Longitude		
				Start	End	
Item	DWR UCIP Field Study			38.866841 °	38.866841 °	
				-121.794047 °	-121.794047 °	
DWR ID	20010

Comment Code						
Inspector Comment						
FS_ID:28486 DS_ID:20010 EP_NO: 10037 Repair Type: Non-Urgent Crossing Status: Found UCIP Comments: Water treatment plant on landside.Working during field visit.Not found- Flap Gate in 6.5 foot by 7.0 foot O.D. concrete distribution box at landward toe. FIELD_STRUCT_DESC: 22-inch concrete encased steel irrigation discharge pipe through the levee, 17.5 feet below the crown. One concrete cutoff wall. 1.5-inch conduit through the levee, 6 feet below the crown. Slant pump on the riverbank. Slide gate in a 60-inch corrugated metal pipe (CMP) riser on the waterside (WS) slope. Flap gate in a 6.5-foot by 7-foot, outside dimensions, concrete distribution box at the landside (LS) toe. Meter pole and sparkling water meter in a 22-inch steel riser at the LS toe. (22-inch concrete encased steel irrigation discharge pipe through the levee, slant pump, and all other appurtenances retained under Automatic Board Order (ABO) issued as Permit No. 10037, 1974 - John Clauss). [Additional Reference(s): DWR Levee Log, 1990. USACE Sacramento O&M Manual 128, March 1960, (HLM 15.26), 18-inch pipe referenced]. FS Date: 1/10/2014

WS view: CMP riser with gate valve and slant pump on steel platform.

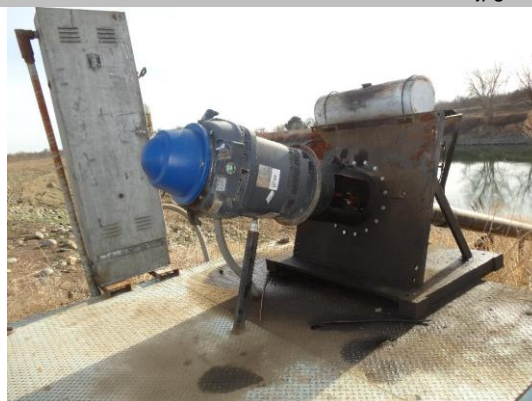
Photo 2 of 3 : UCIP\_FA\_2018\_28486\_52460.jpg

WS view: oil leaking slant pump on steel platform.

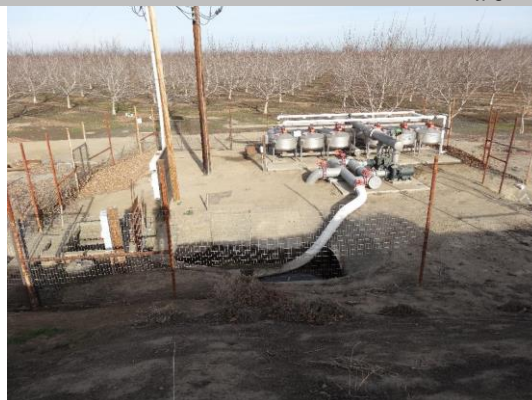
Photo 3 of 3 : UCIP\_FA\_2018\_28486\_52459.jpg

LS view: concrete distribution box on levee toe. Water filtration plant off the levee toe.

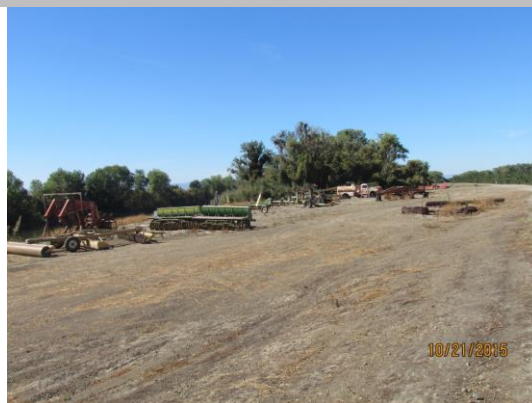
Photo 1 of 1 : FA\_2018\_RD1500\_189\_32\_20180904\_00016.jpg

LM Start	15.76	Rating **	M	Issue No.	32
LM End	15.76	Issue Type +	En	Location *	WS
Category	Earthen Levee			GPS Latitude/Longitude	
				Start	End
Item	Encroachments			38.871828 °	38.871828 °
				-121.804158 °	-121.804158 °
DWR ID	DWR_RD1500_01_s_2017_32				
Comment Code					
EQ : Equipment					
Inspector Comment

View of the equipment on the waterward side of the levee looking upstream. Fall 2015.

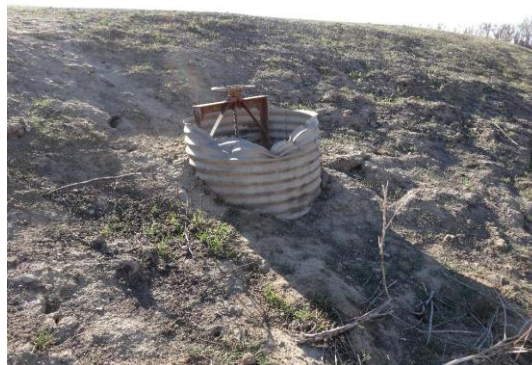
Photo 1 of 3 : UCIP\_FA\_2018\_28489\_52479.jpg

Comment Code						
Inspector Comment						
FS_ID:28489 DS_ID:20081 EP_NO: 8510 Repair Type: Non-Urgent Crossing Status: Found UCIP Comments: Pipe not visible on river bank.Cleaning and clearing require around slide gates. May be abandoned. FIELD_STRUCT_DESC: 24-inch corrugated metal irrigation discharge pipe through the levee, 15 feet below the crown. Slide gate in a 36-inch corrugated metal pipe (CMP) riser on the waterside (WS) slope. Slide gate on a concrete U-shaped headwall and irrigation ditch at the landside (LS) toe. (24-inch corrugated metal irrigation discharge pipe through the levee retained under Permit No. 8510, 1972 - John Clauss Jr. et al.). [Additional Reference(s): DWR Levee Log, 1990. USACE Sacramento O&M Manual 128, March 1960, (HLM 17.14)]. FS Date: 1/14/2014

WS view: CMP riser with slide gate on levee slope.

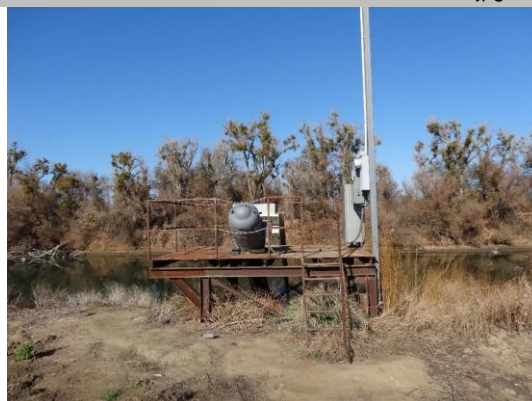
Photo 1 of 3 : UCIP\_FA\_2018\_28490\_52485.jpg

Comment Code					
Inspector Comment					
FS_ID:28490 DS_ID:20066 EP_NO: 1739 Repair Type: Non-Urgent Crossing Status: Found UCIP Comments: Most of the pipe exposed on levee slope.Pipe leakage repaired recently.Siphon breaker requires protection. FIELD_STRUCT_DESC: 20-inch welded steel irrigation discharge pipe through the levee, 5.5 feet below the crown. Slant pump mounted on a steel structure on the waterside (WS). Siphon breaker on the landside (LS) slope. Pipe discharges into a 6-foot by 5.5-foot, outside dimensions, concrete distribution box and irrigation ditch at the LS toe. Fish screen added in 2011. (Installation of a slant pump and a discharge pipe through the levee authorized under Permit No. 1739, 1953 - John Clauss. Installation of a fish screen authorized under Permit No. 18678, [permit missing], [RM 102.50]). [Additional Reference(s): DWR Levee Log, 2005. USACE Sacramento O&M Manual 128, March 1960, (HLM 17.45)]. FS Date: 1/14/2014

WS view: slant pump on steel platform on levee berm.

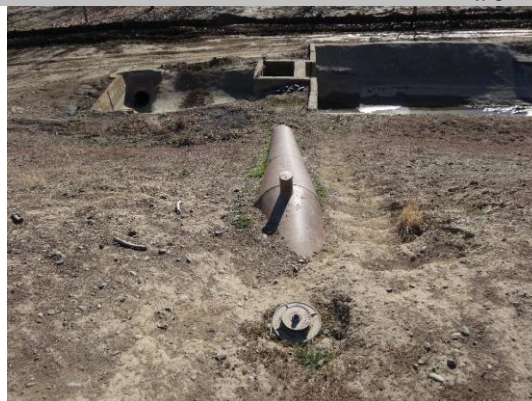
Photo 2 of 3 : UCIP\_FA\_2018\_28490\_52484.jpg

LS view: siphon breaker (bottom) without protection, exposed pipe on levee slope, and distribution box on levee toe.

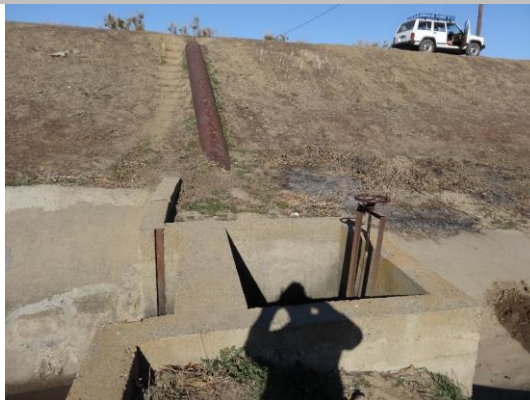
Photo 3 of 3 : UCIP\_FA\_2018\_28490\_52483.jpg

LS view: exposed pipe on levee slope, and concrete distribution box on levee toe.

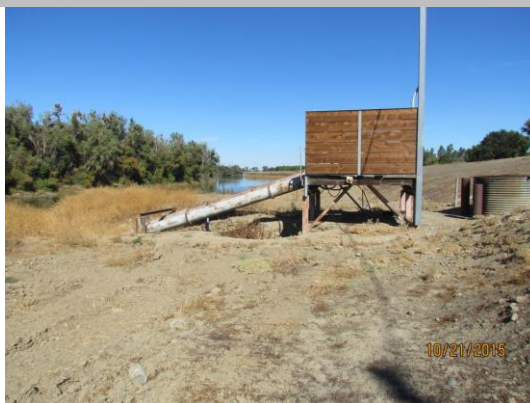
Photo 1 of 3 : FA\_2018\_RD1500\_189\_121\_20180904\_00057.jpg

LM Start	17.34	Rating **	M	Issue No.	121
LM End	17.34	Issue Type +	En	Location *	WS
Category	Earthen Levee			GPS Latitude/Longitude	
				Start	End
Item	Encroachments			38.888137 °	38.888137 °
				-121.807273 °	-121.807273 °
DWR ID	DWR_RD1500_01_f_2015_121				
Comment Code					
PI : Pipe					
Inspector Comment					
Pipe is causing the erosion on the berm of the levee.

Perspective view of the pump on the waterward side of the levee looking upstream. Fall 2015.

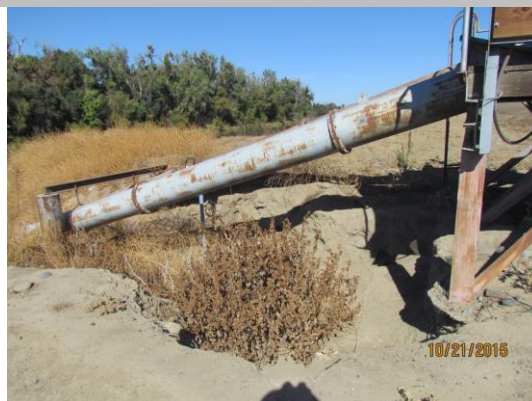
Photo 2 of 3 : FA\_2018\_RD1500\_189\_121\_20180904\_00058.jpg

LM Start	17.34	Rating **	M	Issue No.	121 (cont)
LM End	17.34	Issue Type +	En	Location *	WS
Category	Earthen Levee			GPS Latitude/Longitude	
				Start	End
Item	Encroachments			38.888137°	38.888137°
				-121.807273°	-121.807273°
DWR ID	DWR_RD1500_01_f_2015_121				
Comment Code					
PI : Pipe					
Inspector Comment					
Pipe is causing the erosion on the berm of the levee.

There is erosion underneath the pipe on the waterward berm area. Fall 2015.

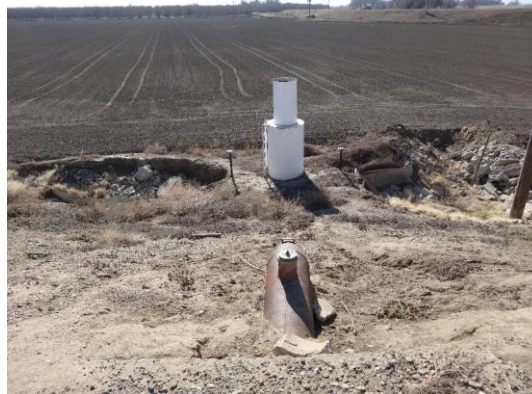
Photo 2 of 3 : UCIP\_FA\_2018\_28505\_52516.jpg

Comment Code					
Inspector Comment					
FS_ID:28505 DS_ID:20068 EP_NO: 2425 Repair Type: Non-Urgent Crossing Status: Found UCIP Comments: Concrete pad on both sides of the levee shoulders.Oil leaks from pump set. FIELD_STRUCT_DESC: 14-inch steel irrigation discharge pipe through the levee, 3 feet below the crown. Two concrete cutoff walls. Slant pump in a corrugated metal pump house on a steel structure on the bank. Meter pole on the slope. Water meter installed on the pipe on the waterside (WS) slope. Siphon breaker on the landside (LS) shoulder. Pipe discharges into a 36-inch, inside diameter, concrete standpipe at the LS toe. (Installation of a pumping plant and discharge pipe authorized under Permit No. 2425, 1956 - Glenn J. Hiatt, [RM 103.66]). [Additional Reference(s): DWR Levee Log, 2005. USACE Sacramento O&M Manual 128, March 1960, (HLM 18.60)]. FS Date: 1/14/2014

LS view: siphon breaker (bottom) on exposed steel pipe on levee slope and steel stand pipe (top) on levee toe.

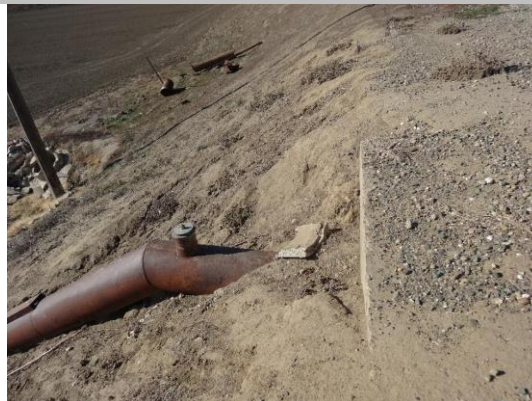
Photo 3 of 3 : UCIP\_FA\_2018\_28505\_52515.jpg

LS view: siphon breaker (left) on exposed steel pipe on levee slope. Concrete pad (right) on levee shoulder.

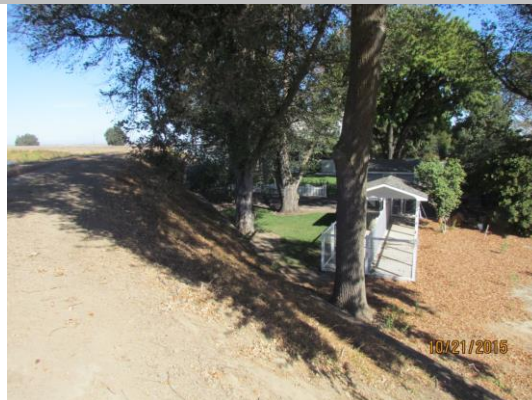
Photo 1 of 1 : FA\_2018\_RD1500\_189\_36\_20180904\_00018.jpg

LM Start	18.98	Rating **	M	Issue No.	36
LM End	18.98	Issue Type +	En	Location *	LS
Category	Earthen Levee			GPS Latitude/Longitude	
				Start	End
Item	Encroachments			38.901570 °	38.901570 °
				-121.791235 °	-121.791235 °
DWR ID	DWR_RD1500_01_s_2012_36				
Comment Code					
BU : Building					
Inspector Comment					
Concrete retaining wall toe of landside levee. Permit #10065

View of the building on the landward side of the levee looking upstream. Fall 2015.

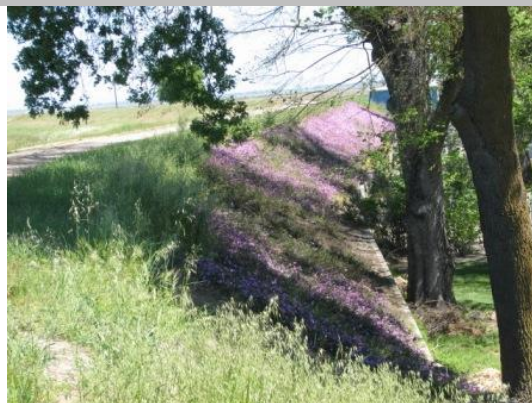
Photo 1 of 2 : FA\_2018\_RD1500\_189\_37\_20180904\_00019.jpg

LM Start	18.98	Rating **	M	Issue No.	37
LM End	19.04	Issue Type +	En	Location *	LS
Category	Earthen Levee			GPS Latitude/Longitude	
				Start	End
Item	Vegetation			38.901659 °	38.902383 °
				-121.791264 °	-121.790574 °
DWR ID	DWR_RD1500_01_s_2012_37				
Comment Code					
V6 : Landscaping					
Inspector Comment

The groundcover is on the levee slope above the concrete retaining wall. The groundcover is irrigated.

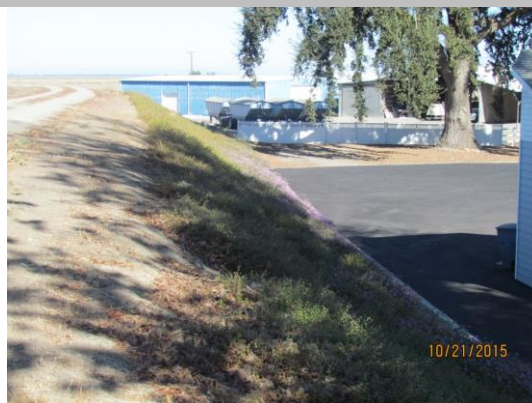
Photo 2 of 2 : FA\_2018\_RD1500\_189\_37\_20180904\_00020.jpg

View of the groundcover on the landward side of the levee looking upstream. Fall 2015.

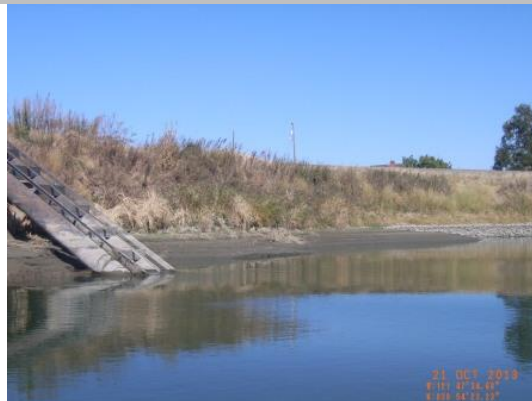
Photo 1 of 1 : FA\_2018\_RD1500\_189\_81\_20181023\_00043.jpg

LM Start	19.16	Rating **	A/W	Issue No.	81
LM End	19.47	Issue Type +	Ma	Location *	WS
Category	Supplemental			GPS Latitude/Longitude	
				Start	End
Item	2017 USACE Erosion Survey, DRAFT			38.904041 °	38.906697 °
				-121.790298 °	-121.792796 °
DWR ID	DWR_RD1500_01_f_2018_81				
Comment Code					
Inspector Comment					
2017 Site ID: SAC 104.5 L					
Status: Eroding					
2017 Field Notes: Site appears stable.					
Site History: 1997 - Cobbles eroded off the clay materials; not much evidence of erosion on the toe; cobble loss on the toe. 2011 - Some minor new erosion.

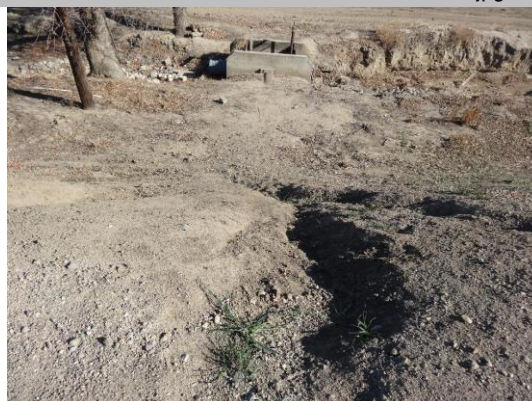
Photo 2 of 3 : UCIP\_FA\_2018\_28506\_52522.jpg

Item	DWR UCIP Field Study			38.905029 °	38.905029 °	
				-121.790076 °	-121.790076 °	
DWR ID	20087					
Comment Code						
Inspector Comment						
FS_ID:28506 DS_ID:20087 EP_NO: 550 Repair Type: Non-Urgent Crossing Status: Found UCIP Comments: Surface erosion on landside slope.Oil leaks from the pump. FIELD_STRUCT_DESC: 14-inch coated steel irrigation discharge pipe through the levee, 4.8 feet below the crown. Two concrete cutoff walls. Slant pump and gate valve in a corrugated metal pump house on a steel structure on the berm. Water meter installed on the pipe on the waterside (WS) slope. Screw gate at the landside (LS) end. Concrete distribution box on the LS. (Installation of a pump and a 14-inch steel discharge pipe through the levee authorized under Permit No. 550, 1931 - P. J. Hiatt. Replacement of a failing 14-inch pipe with the same size pipe through the levee authorized under Permit No. 17648, 2003 - Van Ruiten Brothers). [Additional Reference(s): DWR Levee Log, 1993. USACE Sacramento O&M Manual 128, March 1960, (HLM 19.44)]. FS Date: 1/14/2014

LS view: surface erosion on landside levee slope.

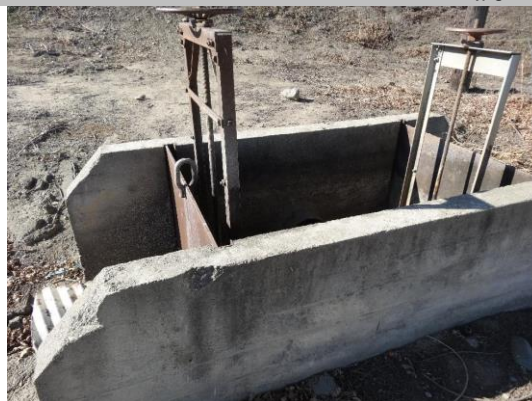
Photo 3 of 3 : UCIP\_FA\_2018\_28506\_52521.jpg

LS view: concrete distribution box on levee toe.

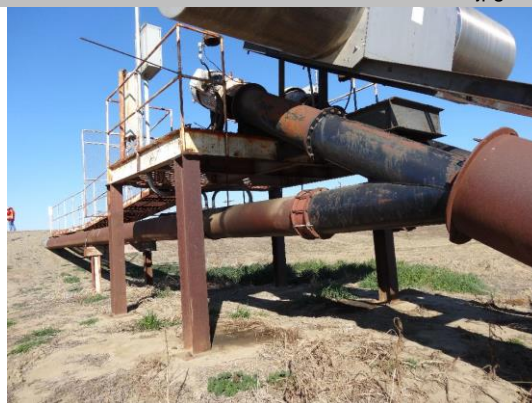
Photo 1 of 3 : UCIP\_FA\_2018\_28524\_52551.jpg

Comment Code						
Inspector Comment						
FS_ID:28524 DS_ID:20004 EP_NO: 15681 Repair Type: Non-Urgent Crossing Status: Found UCIP Comments: Obstructed siphon breakers on landside.Two 3-inch conduit through the levee.Service box on pump platform.Pumping plant was working during the field visit. FIELD_STRUCT_DESC: 1 of 2: 16-inch steel irrigation discharge pipe, asphalt coated inside and out and wrapped with asphalt saturated felt, through the levee, 1.5 feet below the crown. Cutoff wall at the centerline of the levee. Two slant pumps supported by a steel piling structure on the riverbank. Steel walkway to the pump platform. Siphon breakers in steel pipe risers on the landside (LS) shoulder. Pipe discharges into a concrete discharge box off the LS toe. (Installation of a discharge pipe through the levee and a slant pump on the riverbank authorized under Permit No. 15681, 1991 - Blackfraires Investment). FS Date: 1/14/2014

WS view: pipe, walkway, slant pump, and steel platform on levee berm.

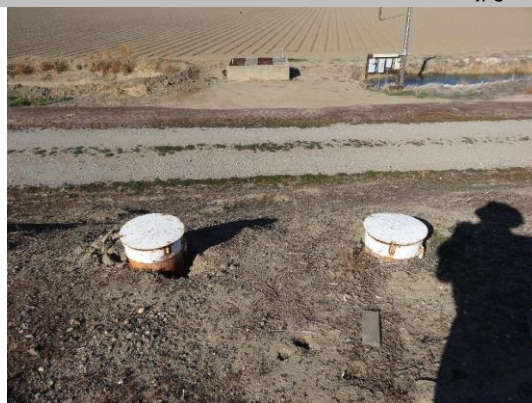
Photo 2 of 3 : UCIP\_FA\_2018\_28524\_52550.jpg

Item	DWR UCIP Field Study			38.907033 °	38.907033 °	
				-121.792943 °	-121.792943 °	
DWR ID	20004					
Comment Code						
Inspector Comment						
FS_ID:28524 DS_ID:20004 EP_NO: 15681 Repair Type: Non-Urgent Crossing Status: Found UCIP Comments: Obstructed siphon breakers on landside.Two 3-inch conduit through the levee.Service box on pump platform.Pumping plant was working during the field visit. FIELD_STRUCT_DESC: 1 of 2: 16-inch steel irrigation discharge pipe, asphalt coated inside and out and wrapped with asphalt saturated felt, through the levee, 1.5 feet below the crown. Cutoff wall at the centerline of the levee. Two slant pumps supported by a steel piling structure on the riverbank. Steel walkway to the pump platform. Siphon breakers in steel pipe risers on the landside (LS) shoulder. Pipe discharges into a concrete discharge box off the LS toe. (Installation of a discharge pipe through the levee and a slant pump on the riverbank authorized under Permit No. 15681, 1991 - Blackfraires Investment). FS Date: 1/14/2014

LS view: siphon breakers in steel pipe risers (bottom) on levee slope and concrete distribution (top) box on levee toe.

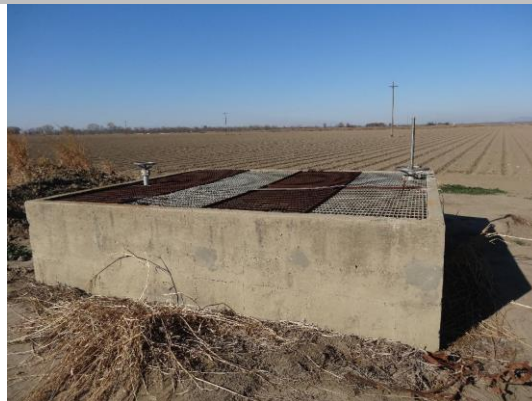
Photo 3 of 3 : UCIP\_FA\_2018\_28524\_52549.jpg

LS view: concrete distribution box on levee toe.

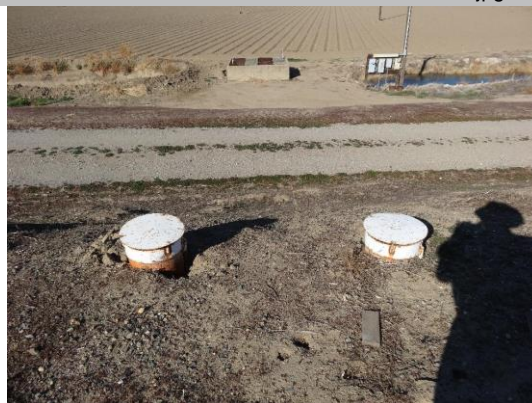
Photo 2 of 3 : UCIP\_FA\_2018\_28927\_53215.jpg

Comment Code						
Inspector Comment						
FS_ID:28927 DS_ID:20022 EP_NO: 15681 Repair Type: Non-Urgent Crossing Status: Found UCIP Comments: Obstructed siphon breakers on landside.Two 3-inch conduit through the levee.Service box on pump platform.Pumping plant was working during the field visit. FIELD_STRUCT_DESC: 2 of 2: 20-inch steel irrigation discharge pipe, asphalt coated inside and out and wrapped with asphalt saturated felt, through the levee, 1.5 feet below the crown. Cutoff wall at the centerline of the levee. Two slant pumps supported by a steel piling structure on the riverbank. Steel walkway to the pump platform. Siphon breakers in steel pipe risers on the landside (LS) shoulder. Pipe discharges into a concrete discharge box off the LS toe. (Installation of a discharge pipe through the levee and a slant pump on the riverbank authorized under Permit No. 15681, 1991 - Blackfraires Investment). FS Date: 1/14/2014

LS view: siphon breakers in steel pipe risers (bottom) on levee slope and concrete distribution (top) box on levee toe.

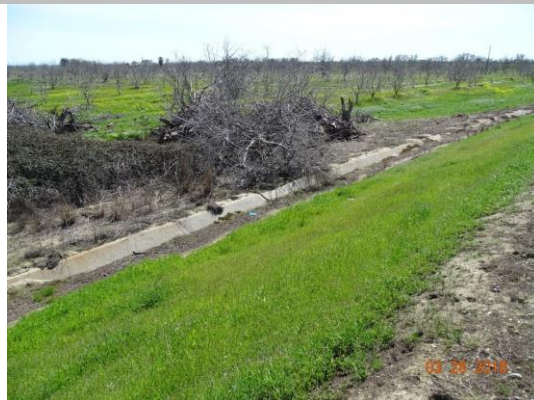
Photo 1 of 1 : FA\_2018\_RD1500\_189\_123\_20180904\_00060.jpg

View of ditch at the landside toe. Spring 2018.

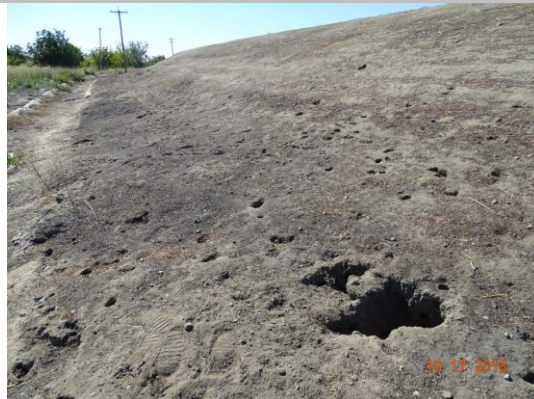
Photo 1 of 1 : FA\_2018\_RD1500\_189\_103\_20181018\_00232.jpg

View of rodent holes on the landside slope. Fall 2018.

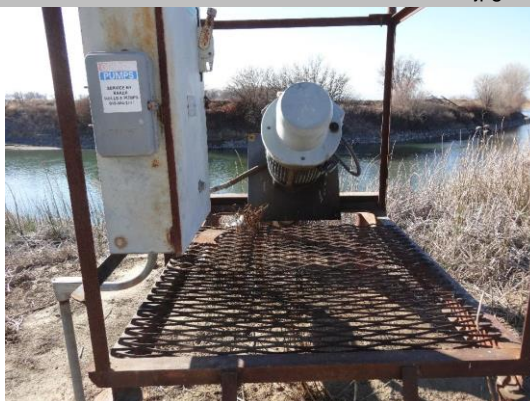
Photo 1 of 3 : UCIP\_FA\_2018\_28527\_52568.jpg

Comment Code					
Inspector Comment					
FS_ID:28527 DS_ID:20070 EP_NO: 11959A Repair Type: Non-Urgent Crossing Status: Found UCIP Comments: Siphon breaker (obstructed) in CMP on landside slope.Power pole on landside toe. FIELD_STRUCT_DESC: 10-inch coated and wrapped steel irrigation discharge pipe through the levee, 3 feet below the crown. Corrugated metal cutoff wall. Slant pump on a steel platform at the riverbank. Obstructed siphon breaker in a corrugated metal pipe (CMP) riser on the landside (LS) slope. Pipe discharges into a 6-foot by 6-foot concrete distribution box on the LS. (Replacement of an existing 10-inch steel pipe with a new 10-inch steel pipe through the levee authorized under Permit No. 11959-A, 1977 - George Van Ruiten Jr.). [Additional Reference(s): DWR Levee Log, 2005. USACE Sacramento O&M Manual 128, March 1960, (HLM 21.50)]. FS Date: 1/14/2014

WS view: slant pump on steel platform on levee berm.

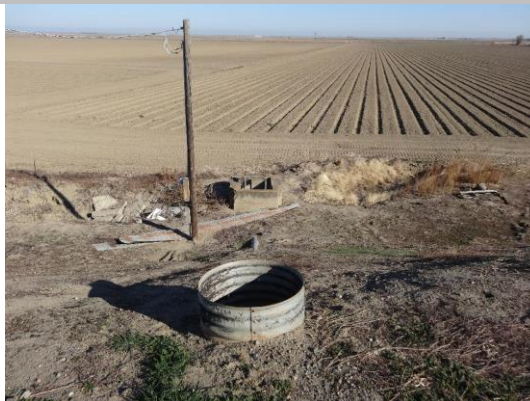
Photo 2 of 3 : UCIP\_FA\_2018\_28527\_52567.jpg

LS view: siphon breaker in CMP riser on levee slope (bottom) and concrete distribution box (top) on levee toe.

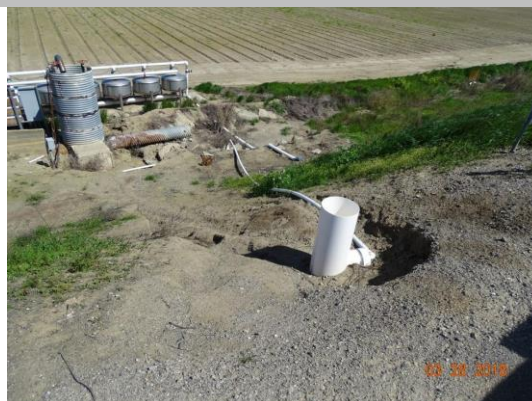
Photo 1 of 1 : FA\_2018\_RD1500\_189\_120\_20180904\_00056.jpg

LM Start	21.58	Rating **	M	Issue No.	120
LM End	21.58	Issue Type +	En	Location *	LS
Category	Earthen Levee			GPS Latitude/Longitude	
				Start	End
Item	Encroachments			38.916207 °	38.916207 °
				-121.808893 °	-121.808893 °
DWR ID	DWR_RD1500_01_s_2018_120				
Comment Code					
PI : Pipe					
Inspector Comment					
Erosion around PVC standpipe.

View of erosion around PVC standpipe. Spring 2018.

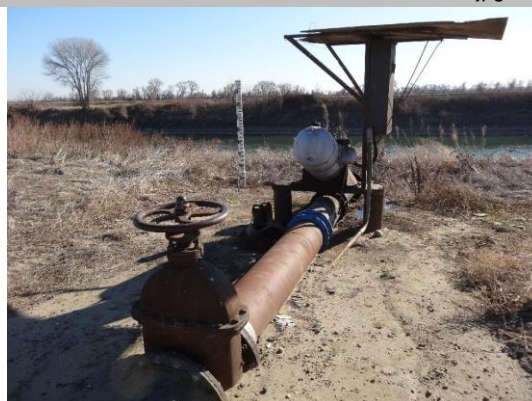
Photo 1 of 3 : UCIP\_FA\_2018\_28528\_52576.jpg

Comment Code					
Inspector Comment					
FS_ID:28528 DS_ID:20071 EP_NO: 10063 Repair Type: Non-Urgent Crossing Status: Found UCIP Comments: Water leaks near pump. Obstructed siphon breaker in CMP on landside.Plant was working during field visit. FIELD_STRUCT_DESC: 16-inch steel irrigation discharge pipe through the levee, 6.3 feet below the crown. Corrugated metal cutoff wall. 1.5-inch conduit through the levee, 6.5 feet below the crown. Slant pump and gate valve on riverbank. Siphon breaker in a 24-inch corrugated metal pipe (CMP) riser on the landside (LS) slope. 5-foot by 5-foot concrete distribution box on the LS. CMP standpipe on the LS toe. Power pole and one anchor at the LS toe. (Automatic Board Order (ABO) issued as Permit No. 10063, 1974 - Thomas L. Nelson). [Additional Reference(s): DWR Levee Log, 2005. USACE Sacramento O&M Manual 128, March 1960, (HLM 21.83)]. FS Date: 1/14/2014

WS view: slant pump on steel platform on levee berm. Exposed steel pipe with gate valve also on levee berm.

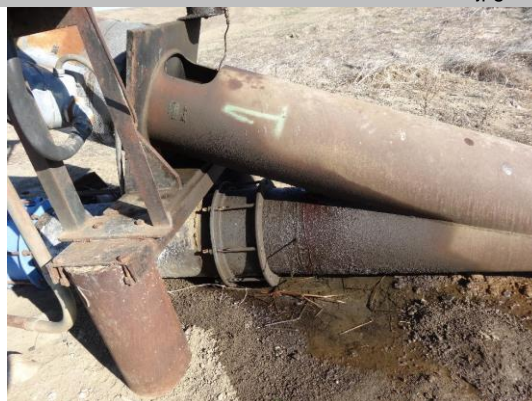
Photo 2 of 3 : UCIP\_FA\_2018\_28528\_52575.jpg

WS view: leaky inlet pipe near pump platform.

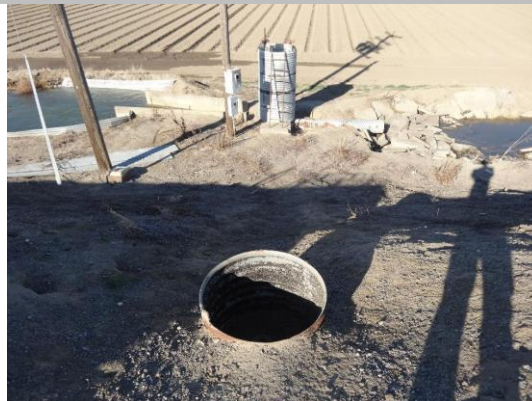
Photo 3 of 3 : UCIP\_FA\_2018\_28528\_52574.jpg

LS view: siphon breaker in CMP riser on levee slope (bottom) and CMP stand pipe (top) on levee toe.

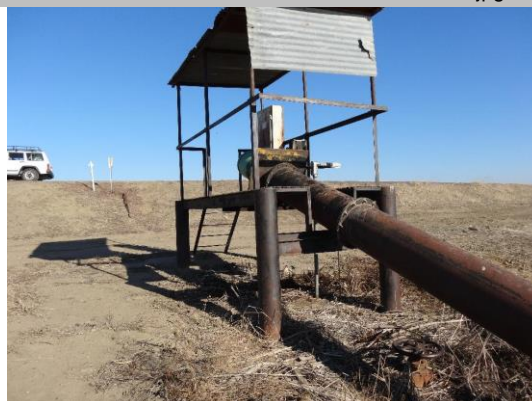
Photo 1 of 3 : UCIP\_FA\_2018\_28583\_52627.jpg

Comment Code						
Inspector Comment						
FS_ID:28583 DS_ID:19995 EP_NO: 10851 Repair Type: Non-Urgent Crossing Status: Found UCIP Comments: Exposed conduit on both slopes of the levee. Plant was working during field visit. Water was leaking from pipe joint near pump.Obstructed siphon breaker in CMP. FIELD_STRUCT_DESC: [Pumping Plant No. 2] 14-inch steel irrigation discharge pipe through the levee, 6.2 feet below the crown. Corrugated metal cutoff wall. 2-inch conduit through the levee, 5 feet below the crown. Pump and gate valve on a steel platform at the riverbank. Switch panel on the berm. Siphon breaker in a 24-inch corrugated metal pipe (CMP) riser on the landside (LS) shoulder. Pipe discharges into a 36-inch CMP standpipe at the LS toe. Meter pole at the LS toe. (Installation of three centrifugal pumps authorized under Permit No. 2895, 1958 - George Van Ruiten). [Additional Reference(s): DWR Levee Log, 1993. USACE Sacramento O&M Manual 128, March 1960, (HLM 23.00), 14-inch pipe referenced]. FS Date: 1/14/2014

WS view: slant pump on steel platform on levee berm.

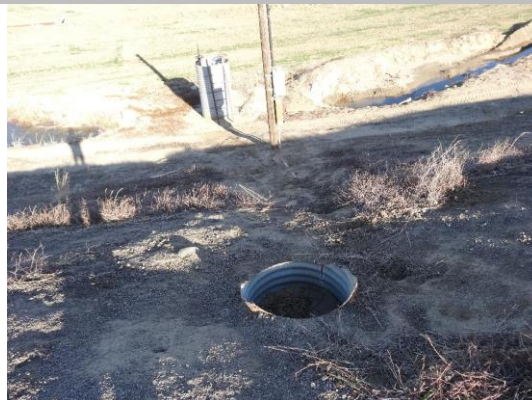
Photo 3 of 3 : UCIP\_FA\_2018\_28583\_52625.jpg

LS view: siphon breaker in CMP riser on levee slope (bottom) and CMP stand pipe (top) on levee toe.

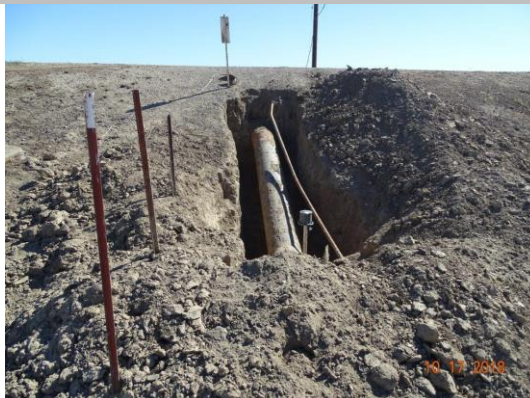
Photo 1 of 3 : UCIP\_FA\_2018\_53023\_78166.jpg

FS\_ID:53023  
DS\_ID:20072  
EP\_NO: 2895  
Repair Type: Urgent  
Crossing Status: Found  
UCIP Comments: 10/18/2018 WS levee slope was disturbed to perform pipe maintenance. Unable to locate a permit for this work. Crossing remains "Urgent" due to soil disturbance on WS levee slope. (O.Yakimov - DWR)Most of the pipe exposed on levee slopes.Leaky pump. Obstructed siphon breaker.Not found- Concrete headwall at landward toe.  
FIELD\_STRUCT\_DESC: [Pumping Plant No. 1] 14-inch steel irrigation discharge pipe through the levee, 6.5 feet below the crown. Corrugated metal cutoff wall. 1.5-inch conduit through the levee, 4 feet below the crown. Slant pump and control panel on steel structure on the berm. Siphon breaker in a 24-inch corrugated metal pipe (CMP) riser on the landside (LS) shoulder. 36-inch concrete standpipe at the LS toe. Concrete headwall at the LS toe. Meter pole at the LS toe. (Installation of three centrifugal pumps authorized under Permit No. 2895, 1958 - George Van Ruiten). [Additional Reference(s): DWR Levee Log, 2005. USACE Sacramento O&M Manual 128, March 1960, (HLM 23.92), 24-inch pipe referenced].

WS levee slope was excavated to do pipe maintenance, photo courtesy of Zach Jojola.

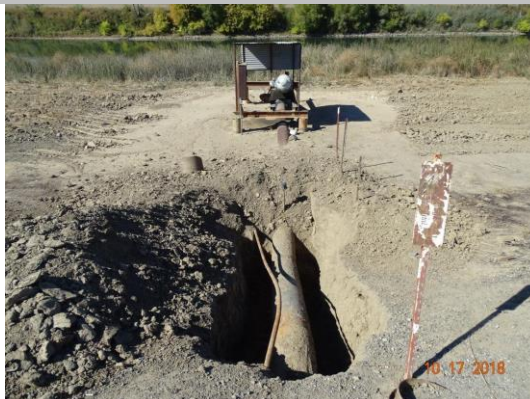
Photo 2 of 3 : UCIP\_FA\_2018\_53023\_78167.jpg

Levee crown view: WS levee slope was excavated to do pipe maintenance, photo courtesy of Zach Jojola.

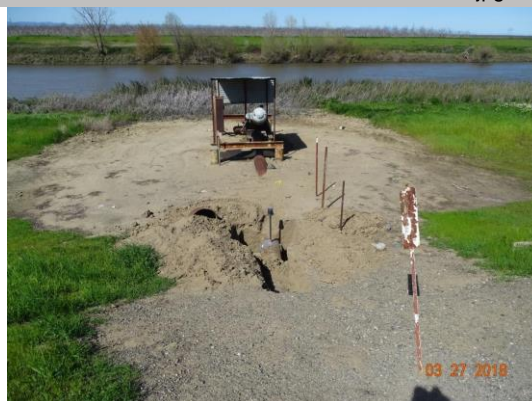
Photo 3 of 3 : UCIP\_FA\_2018\_53023\_77546.jpg

WS view: Currently installing a new meter. Still needs backfill. Levee inspector: Zachary Jojola.

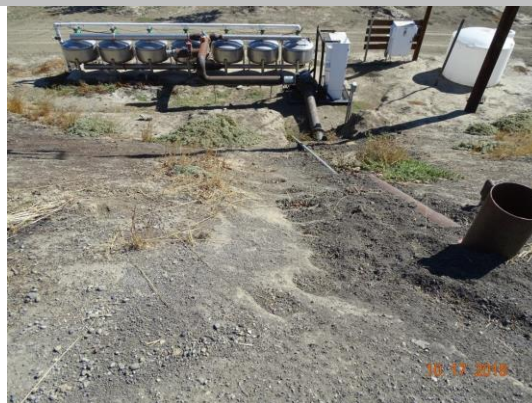
Photo 1 of 1 : FA\_2018\_RD1500\_189\_112\_20181018\_00231.jpg

LM Start	23.66	Rating **	M	Issue No.	112
LM End	23.66	Issue Type +	En	Location *	LS
Category	Earthen Levee			GPS Latitude/Longitude	
				Start	End
Item	Encroachments			38.930280 °	38.930280 °
				-121.834957 °	-121.834957 °
DWR ID	DWR_RD1500_01_s_2018_112				
Comment Code					
ST : Stairway					
Inspector Comment					
Landowner has dug stairs into the levee adjacent to standpipe.

View of stairs on the landside slope. Fall 2018.

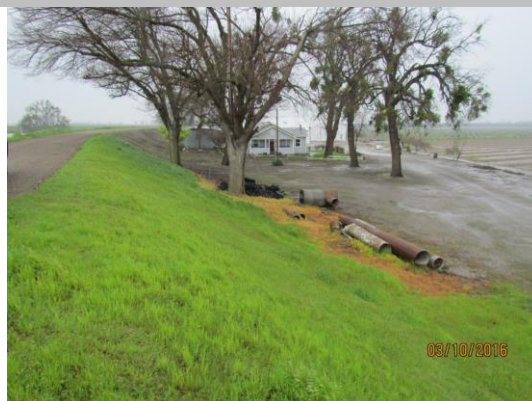
Photo 1 of 1 : FA\_2018\_RD1500\_189\_176\_20180904\_00077.jpg

View of the pipes along the toe of the landward side of the levee looking upstream. Spring 2016.

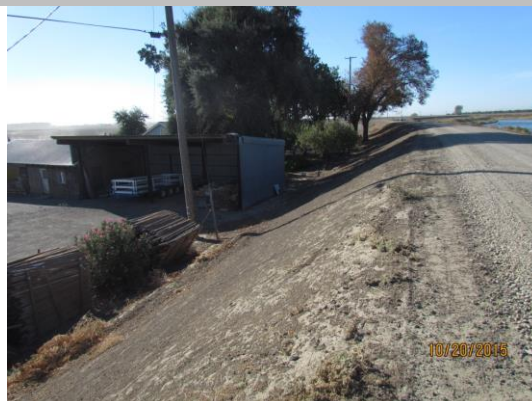
Photo 1 of 1 : FA\_2018\_RD1500\_189\_42\_20180904\_00022.jpg

LM Start	23.77	Rating **	M	Issue No.	42
LM End	23.77	Issue Type +	En	Location *	LS
Category	Earthen Levee			GPS Latitude/Longitude	
				Start	End
Item	Encroachments			38.931838 °	38.931838 °
				-121.834437 °	-121.834437 °
DWR ID	DWR_RD1500_01_s_2012_42				
Comment Code					
EQ : Equipment					
Inspector Comment					
Some equipment at landside toe.

View of the barn and equipment on the landward side of the levee looking downstream. Fall 2015.

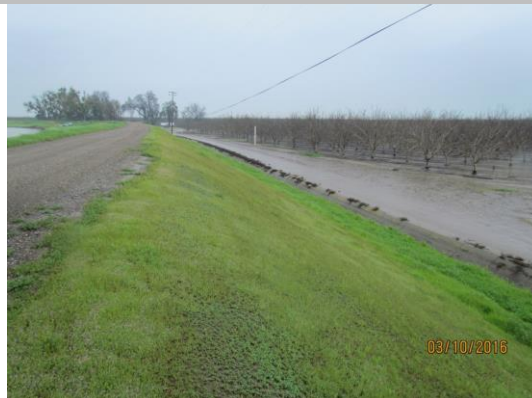
Photo 1 of 1 : FA\_2018\_RD1500\_189\_979\_20180904\_00081.jpg

LM Start	24.17	Rating **	M	Issue No.	979
LM End	24.31	Issue Type +	En	Location *	LS
Category	Earthen Levee			GPS Latitude/Longitude	
				Start	End
Item	Encroachments			38.936419 °	38.938426 °
				-121.830220 °	-121.829365 °
DWR ID	DWR_RD1500_01_s_2012_979				
Comment Code					
DT : Ditch					
Inspector Comment					
Concrete lined ditch located at the levee toe on the landward side of the levee.

View of the ditch on the landward side of the levee looking upstream. Spring 2016.

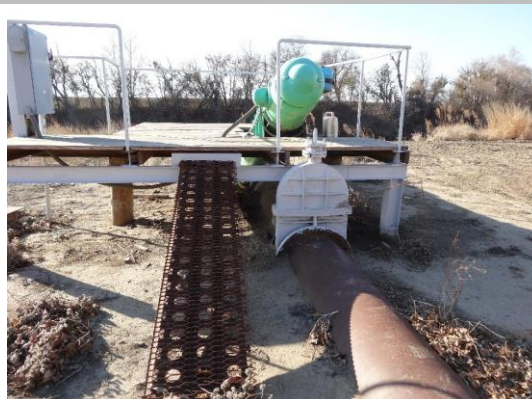
Photo 1 of 3 : UCIP\_FA\_2018\_28603\_52667.jpg

Comment Code					
Inspector Comment					
FS_ID:28603 DS_ID:24757 EP_NO: 10057 Repair Type: Non-Urgent Crossing Status: Found UCIP Comments: Plant was working during field visit.Leaky pipe near pump. FIELD_STRUCT_DESC: 24-inch steel irrigation discharge pipe through the levee, 6.5 feet below the crown. Corrugated metal cutoff wall. 1.5-inch conduit through the levee, 4 feet below the crown. Wooden walkway to a slant pump in a corrugated metal pump house on the berm. Gate valve on the berm. Hersey-Sparling meter on pipe at the waterside (WS) toe. Siphon breaker in a 24-inch corrugated metal pipe (CMP) riser on the landside (LS) shoulder. Pipe discharges into a 4-foot by 7-foot, inside dimensions, concrete distribution box at the LS toe. Meter pole at the LS toe. Field visit on 01/14/2014. (24-inch steel irrigation discharge pipe through the levee, slant pump, and all other appurtenances retained under Automatic Board Order (ABO) issued as Permit No. 10057, 1974 - David S. Lewis, care of Broomieside Farms). [Additional Reference(s): DWR Levee Log, 1990. USACE Sacramento O&M Manual 128, March 1960, (HLM 24.60)]. FS Date: 1/14/2014

WS view: slant pump on steel platform at levee berm. Walkway, exposed pipe, and gate valve on the berm.
